An analysis of inflow and infiltration from unsealed septic tank access ports

Watertight tanks are generally overlooked as a solution to inflow and infiltration problems in municipal and decentralised wastewater systems. The use of watertight tanks can dramatically reduce treatment costs, reduce overflow events and help contain the ever-increasing problem of inflow and infiltration (I&I).

Eric Barger, C R Barger & Sons, Kingston, Tennessee, USA

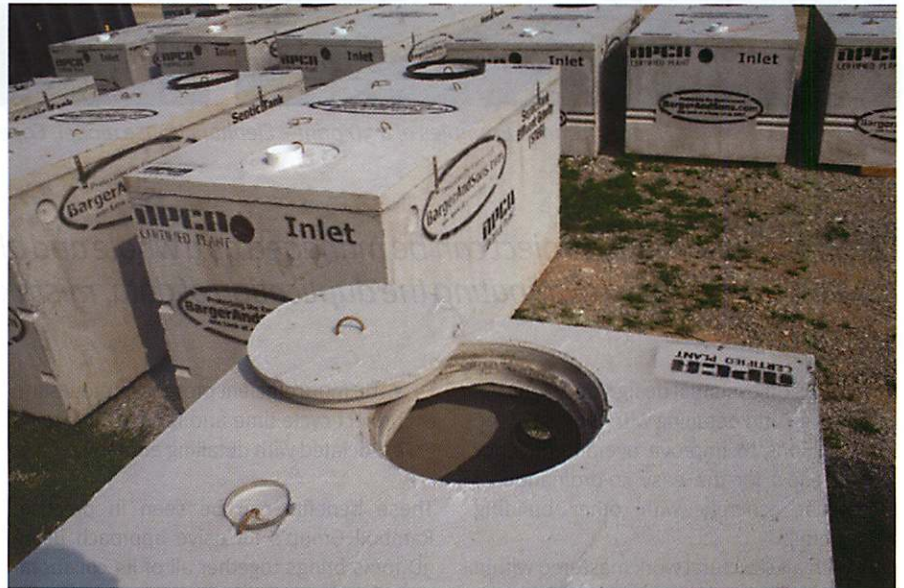
Figure 1: The access port that was allowing the water to leak through.

However, when the first tank was uncovered, it was immediately apparent that the inlet side access port lid (see Figure 1), which measured 460mm in diameter, was allowing surface water to enter the tank. All of the tanks showed varying degrees of I&I during the inspection.

The next step was to seal each of the inlet access port lids on each tank in System 1 with a high-quality butyl sealant to ensure a watertight seal. Fortunately, the unsealed lid was close to ground level, allowing an easy fix. System 1 and System 2 tank specifications were now identical to each other and should perform equally well against I&I into the collection system. After evaluating the following month's meter readings, the success of applying the butyl sealant on the inlet access port lids became evident, as System 1 showed a dramatic decrease in treated sewage. Sixty per cent of the total purchased water was now entering the sewage treatment facility, cutting the treated wastewater by more than half. This validated that the I&I problem originated from the unsealed access port lids. Table 1 shows the purchased water and treated effluent comparisons.

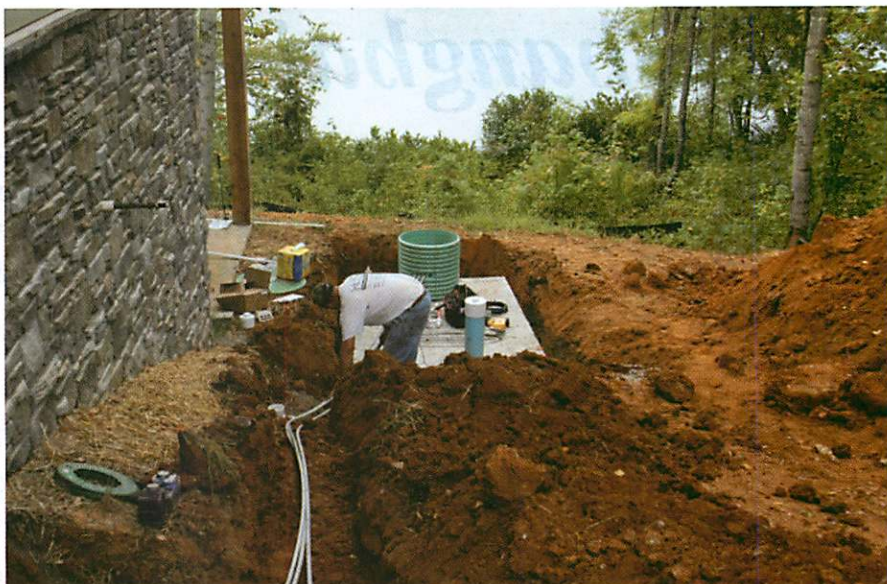
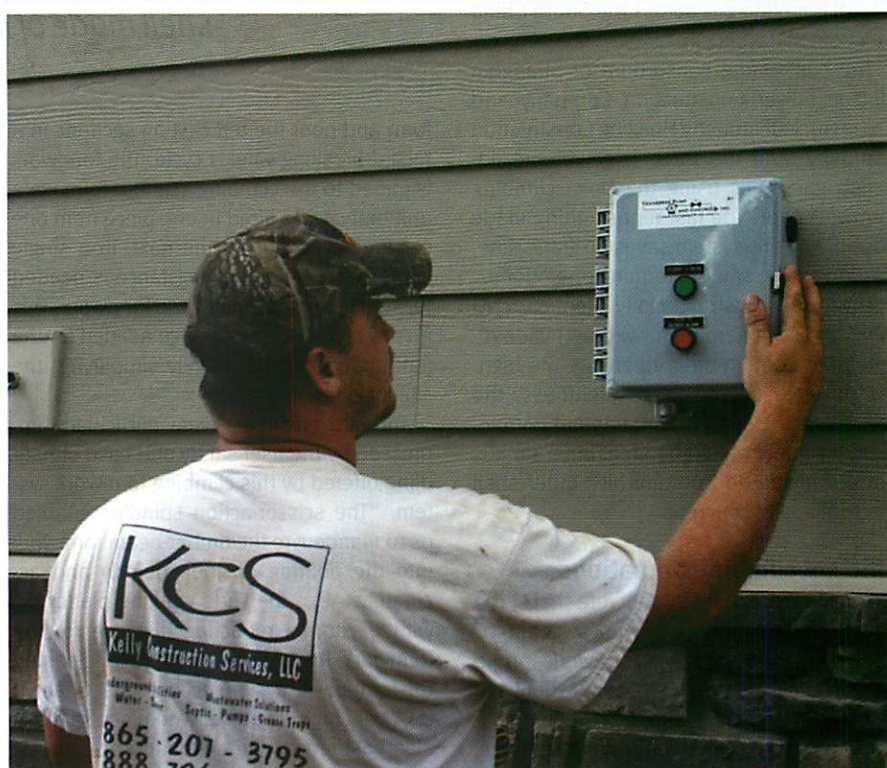
Figures 2 and 3: A typical system being installed by a contractor for a utility.
